## Additional notes about the 2400 MHz power amplifier (v 4.0)

This publication describes the problems encountered during assembly, together with suggestions for solutions.

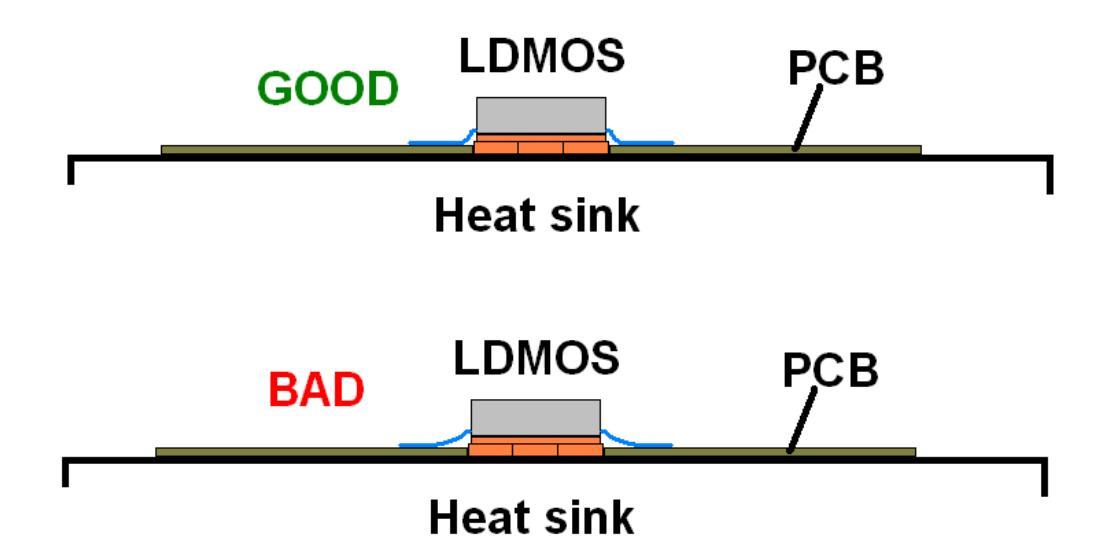
Figure 4. Good and bad way of soldering transistors

Measurements of the amplifier converted this way showed a slight parameters deterioration due to a detuning of the matching circuits of the transistors. If terminals transistors will be bent too mild (Fig. 4), degradation of parameters may be greater. Using a power meter, the amplifier may be additionally tuned, which will improve the performance.

It is important to screw tight the board and transistors to the heat sink, using all holes in the board (20 + 4).

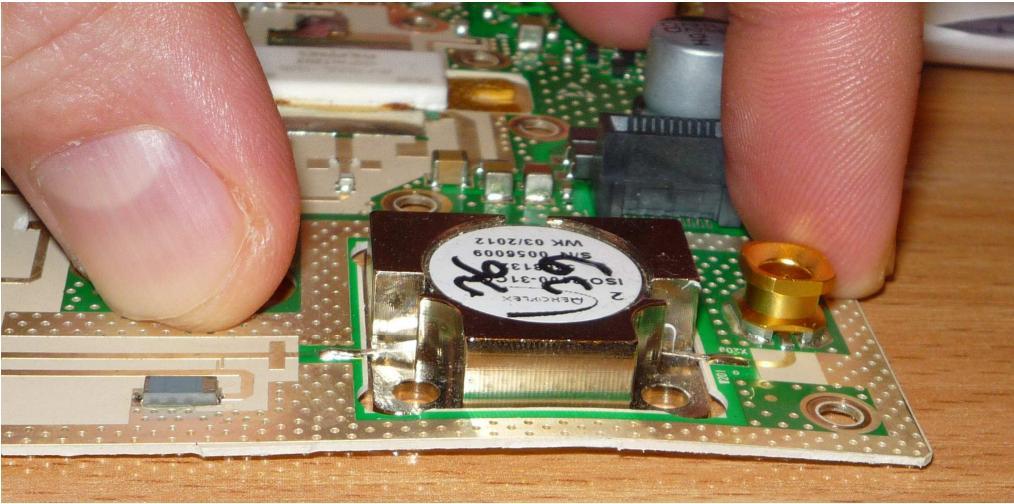
Figure 5. Output isolator on a flat surface

Copyright by Andrzej SP8XXN and Tom SP5XMU March 2021 The output isolator, if it has not previously been replaced by a 50 ohm semi rigid cable, can be screwed to flat heat sink without any modifications. It should be paid attention, whether the isolator terminals are not in contact with its housing (ground). See Figure 5.
